## Identification of Dorchester Buff sandstone for historic restoration

935 Broadway, New York City

(5/12/2020) Fabricator's Secret was asked to identify the source of sandstone for repair & replacement of the façade at 935 Broadway (see photos of building on this page). By this report, we confirm that we located the original stone, and it is still available for cut to size projects.

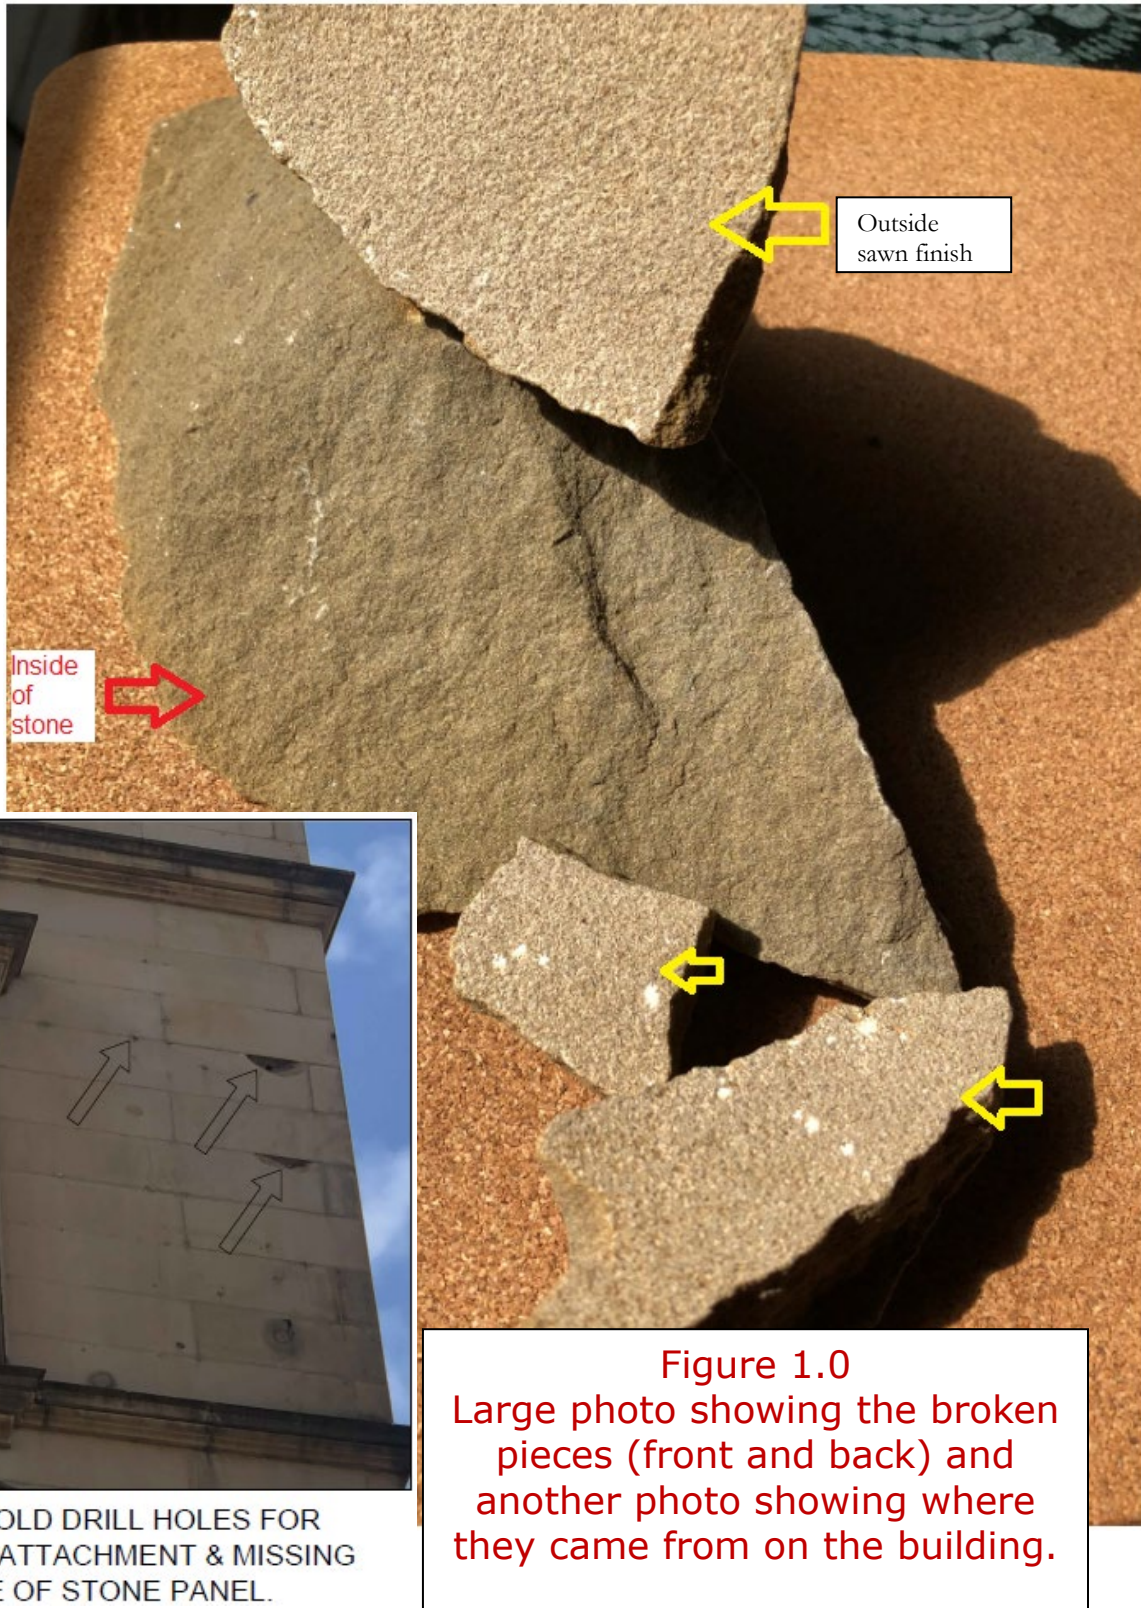
P16: OLD DRILL HOLES FOR  
SIGN ATTACHMENT & MISSING  
PIECE OF STONE PANEL.

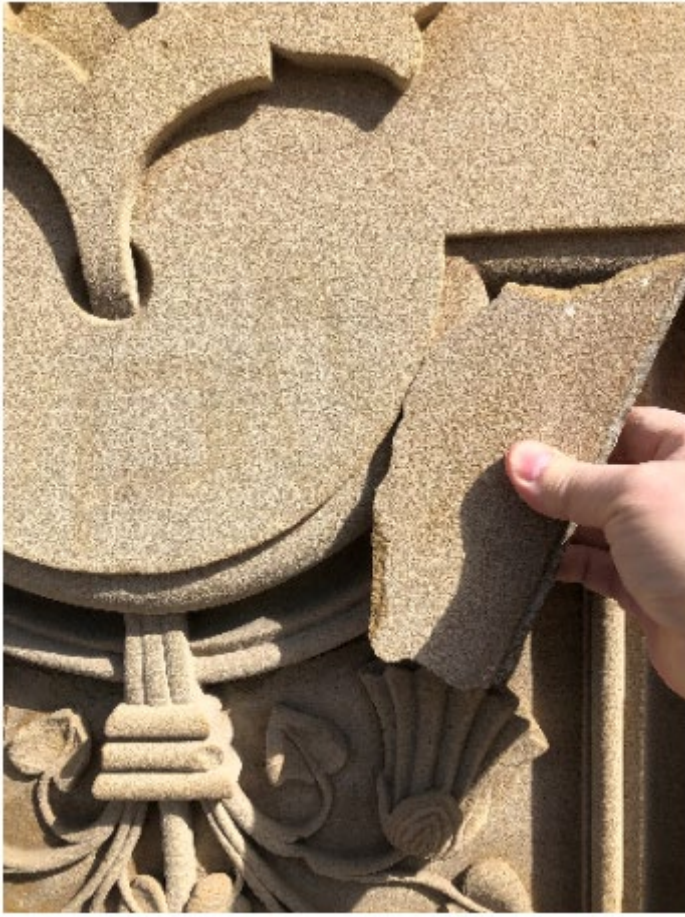
Figure 3.0 – left  
Comparison of sample from 935  
Broadway versus sandstone at  
Bethesda Terrace.

Figure 4.0 – below  
Comparison of uncut back of  
sample from 935 Broadway  
versus exposed interior of stone  
at Bethesda Terrace.

Simultaneously, we reviewed other historic buildings in New York from the same time period, and found that the great staircase in the Bethesda Terrace in Central Park was also a sandstone from New Brunswick. A quick visit to Central Park confirmed the similarity between our façade pieces and the Bethesda balustrade and cheekwalls. See photos (Figure 3.0 and 4.0) documenting the sample from 935 Broadway shown next to the posts, balusters, and rails in Central Park, in Appendix II.

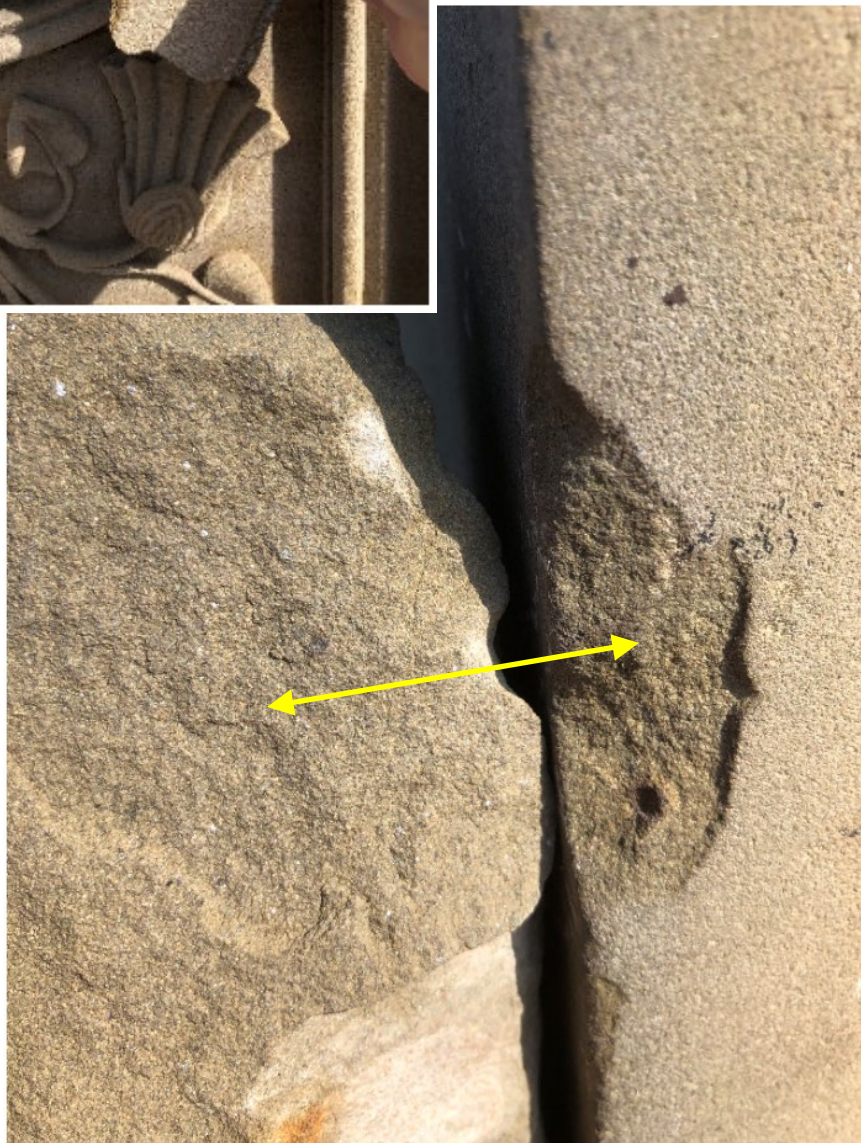
**Figure 5.0**  
**Surface comparison of new Dorchester Buff (sawn finish) vs actual piece of façade from 935 Broadway.**

- 1) The finish he says that is closest to ours is the modern sawn cut finish (see Figure 5.0 in appendix - sample available upon request). When you saw cut the sandstone, you slice many of the silicate particles (the sand) on the edge, making them more prominent and a higher percentage of the face’s surface.

You also dislodge some brownish material between the silicate, making the face appear even lighter and closer to the color of sand.
